# Suited for the occasion

Tammy Bomia and Davie Peguero PE, CSNRI, USA, assess the use of composite technology in providing improved protection during HDD installations.

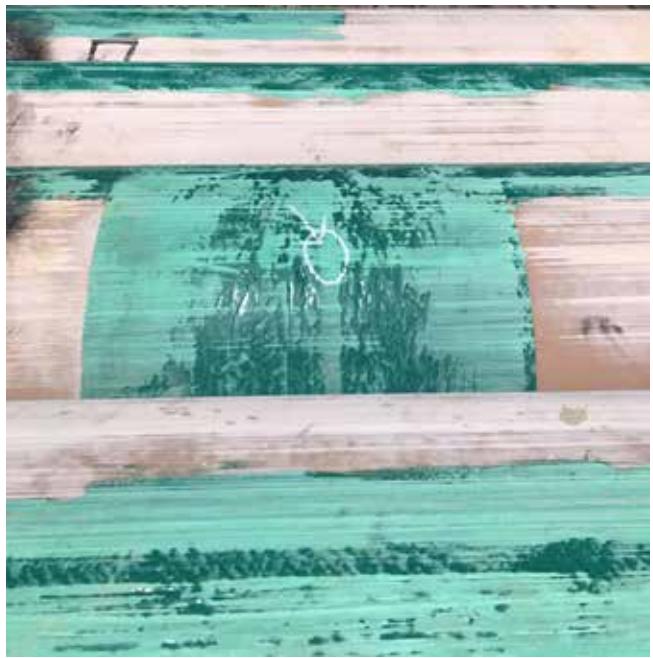
**Figure 1.** Pipeline with only epoxy coating was pulled twice, resulting in damage to the steel in both cases. When Scar-Guard was applied to the line for the third attempt, the installation was carried out without incident. Photo courtesy of CSNRI.

In another application, a company was installing a new, 24 in. (609.6 mm) regulated pipeline and encountered a challenging bore path approximately 1200 ft (366 m) long, under a river. The pipeline, which was being placed through cobble, was contending with one of the most difficult soil conditions the contractor had ever seen.

The first run set the tone for the project. Not only was the carbide cone lost in the hole, but this section of pipeline was being pushed through the cobble, which resulted in the coating being scarred down to metal loss. A site engineer assessing the damage suggested the scarring on the pipe had resulted from the cone dragging at a tangent along the line. While this seemed likely, the team could not remove the carbide cone, and drilling another hole would be cost prohibitive, amounting to approximately US\$1.5 million.

The team decided to perform a test pull on a 300 ft (91 m) section of pipe protected with Scar-Guard to determine if it could withstand the abrasion from the cobble and carbide. A successful test proved that the composite was equal to the task.

The field team wrapped the 300 ft (91 m) section of line, as well as every weld, with Scar-Guard to provide maximum protection during the pull, enabling the successful HDD installation with full encapsulation of the 1200 ft (366 m) of

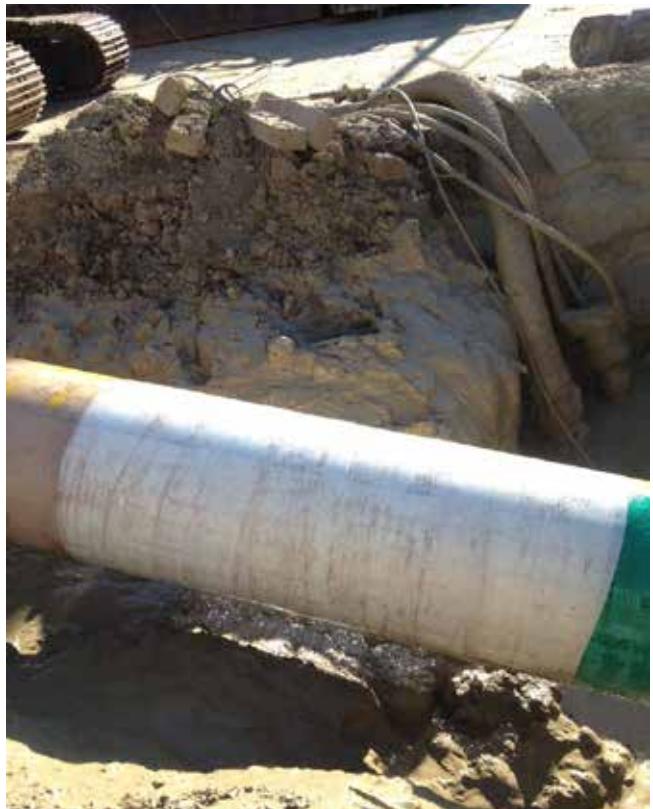
**Figure 2.** After the line was installed with Scar-Guard applied, it was pulled back and examined for damage. A close inspection revealed that Scar-Guard provided the necessary protection to ensure a successful job.

Technicians welded a length of pipe to the line and applied four layers of Scar-Guard over the first field joint 40 ft (12 m) behind the bore head as a sacrificial, mechanically protective coating. The location was specifically chosen to ensure that the composite reinforced coating would be exposed to the brunt of all forces to which the pipeline would be subjected.

With the composite applied, the pilot section of pipe was installed following the same methodology that would be used for the pipeline. After the line was installed, it was pulled back and examined for damage. Although there were some areas of the sacrificial composite coating that experienced abrasion, there was no damage to the anti-corrosion coating protecting the pipeline. A close inspection by the coating inspector, utility engineer, and contractor's superintendent revealed that the composite had provided the necessary protection to ensure a successful job.

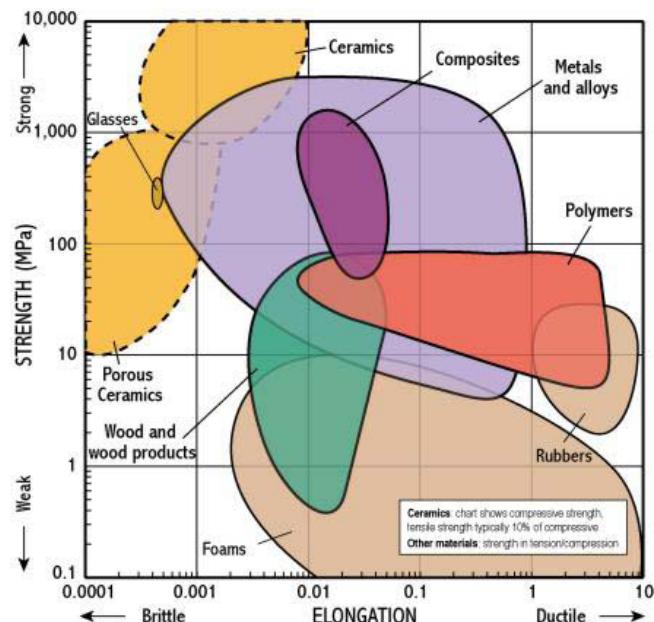
Figure 3. Test data show that glass composites are eight times stronger than epoxy coatings. Data courtesy of CSNRI.

Using a universal tensile machine, with the only difference being specimen geometry, engineers conducted tests that proved glass composites are eight times stronger than epoxy coatings. Composites also outperformed epoxy coatings in terms of stiffness, with composites performing to 4000 ksi, compared with epoxy coating, which achieved only 250 ksi.

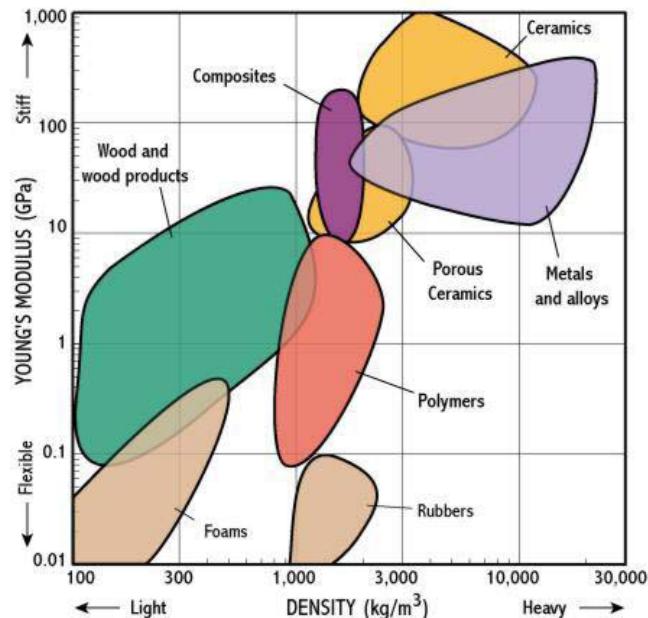
Figure 4. Composites outperformed epoxy coatings in terms of stiffness, with composites performing to 4 000 000 psi, compared with epoxy coating, which achieved only 250 000 psi.

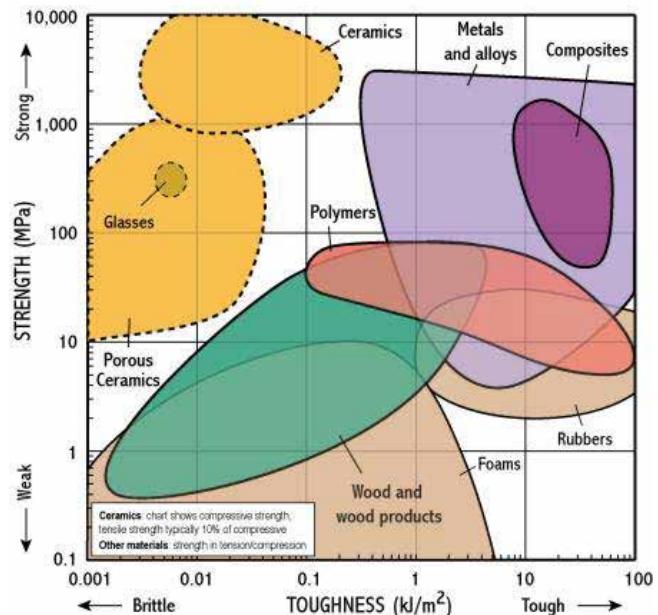
Figure 5. Lab results show the fracture toughness of composites is superior to other materials tested.

Fracture toughness results told a similar story. Most field joint coating failures are the result of shearing, tearing, and crack opening, which are fundamentally related to their fracture toughness properties. The research team selected two commercially available liquid epoxies used for field joint coating and two popular composites used to protect field joint coatings, conducting multiple tests to validate the properties. For the test, specimens were pre-cracked and then tested to failure using a tensile machine. In the end, results showed that the composites outperformed the other materials by a factor of 20 to 60.

In terms of performance, this means that because of its lower strength, stiffness, and fracture toughness, an epoxy will chip, crack, peel, spall, flake, and/or blister before a composite under similar loading.
