Polyethylene Repair Products - CRP-PE

CRP-PE Repair Patch for high-temperature polyethylene coated pipelines

Pipeline Repair Patch

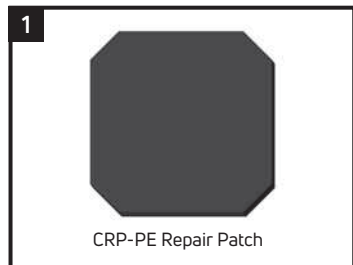
The Coating Repair Patch (CRP-PE) is supplied in 150mm x 150mm (6" by 6") patches or in rolls 150mm wide by 15m long, and can be field cut-to-size.

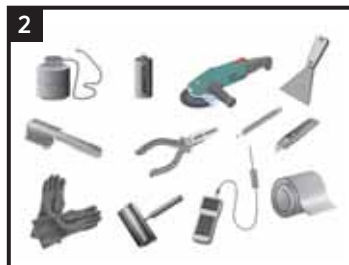
Equipment List

Propane tank, hose, torch & regulator; Appropriate tools for surface abrasion: grinder, 80-120 grit sandpaper; Appropriate tools for cleaning: rags & approved cleaner; Tools: roller, digital thermometer, knife, marker, measuring tape, scraper / spatula & pliers; Standard safety equipment; gloves, goggles, hard hat, etc.

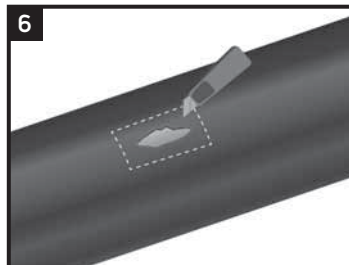
Major Repair: Exposed Metal

Using a knife, carefully cut out only the damaged coating into a smooth sided shape.
