## Using Pipeline Coatings with Cathodic Protection

### Protective Coatings Need to Maintain Integrity under Operating Environments and in the Presence of CP

Kathy Riggs Larsen, *Editor*

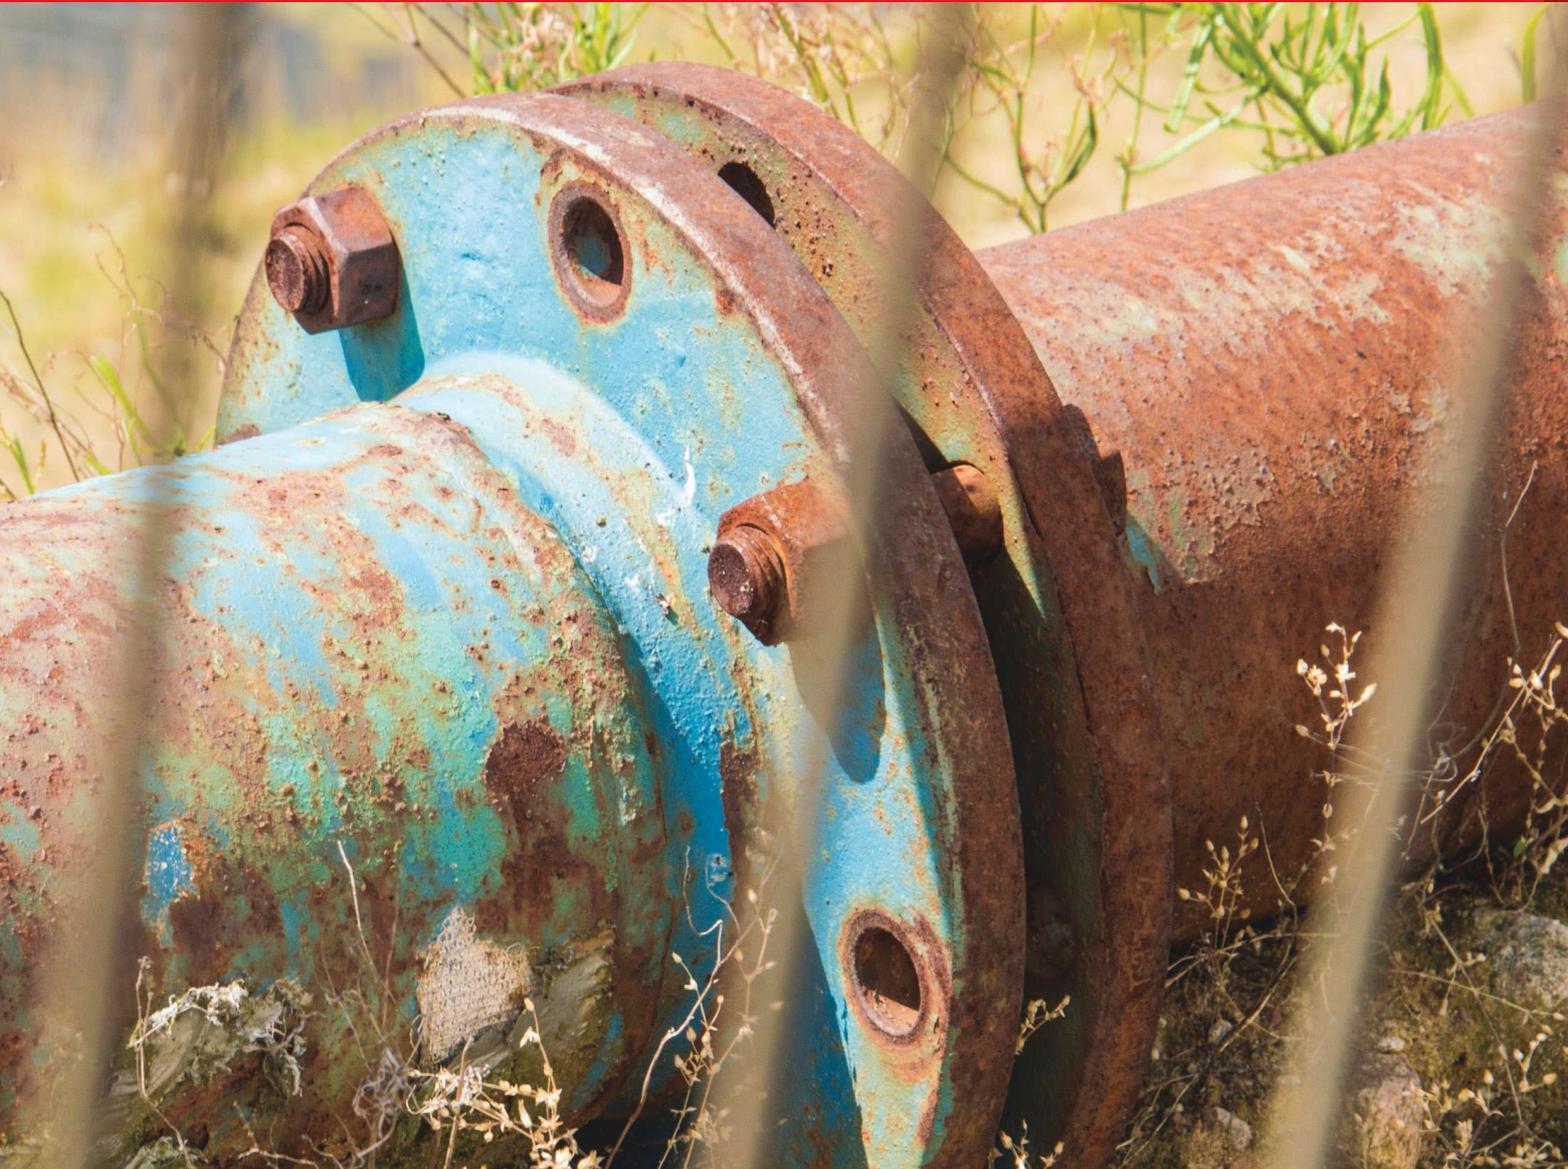
Cathodic disbondment on an in-service buried pipeline coating. Photo courtesy of Matt Dabiri.

Cathodic disbondment is the destruction of adhesion between a coating and the coated surface due to cathodic reaction products.<sup>3</sup> If the coating does not have any defects, then cathodic disbondment typically will not occur. If there is a coating holiday/discontinuity or other defect, however, CP current will pass into the metal at the coating defect, resulting in a

highly alkaline environment due to the formation of hydroxyl groups at the cathode (steel) surface. If a coating is not stable in the CP environment, the highly alkaline environment coupled with the polarized potential can cause the coating to lose adhesion and disbond from the substrate. The amount of current flow (current density) is determined by the amount of current available and the size of the coating defect. As the defect gets larger, the current flow increases and more of the coating is pushed away from the metal. This can result in rapid disbondment and coating breakdown.

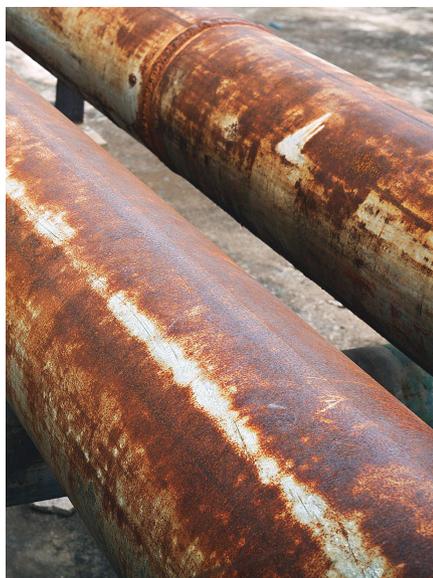
To determine cathodic disbondment using TM0115-2015, four radial cuts using a sharp blade are made through the drilled holiday in the sample. A rigid knife is used to lift and remove the disbonded coating at the drilled holiday until no more disbondment can be detected. The disbonded area is calculated using the difference between the average disbondment diameter and the drilled holiday diameter. Photo courtesy of Dennis Wong.
